## ENERGY EFFICIENT ENGINE

### HIGH PRESSURE TURBINE THERMAL BARRIER COATING SUPPORT TECHNOLOGY REPORT

E.C. Duderstadt and P. Agarwal

GENERAL ELECTRIC COMPANY

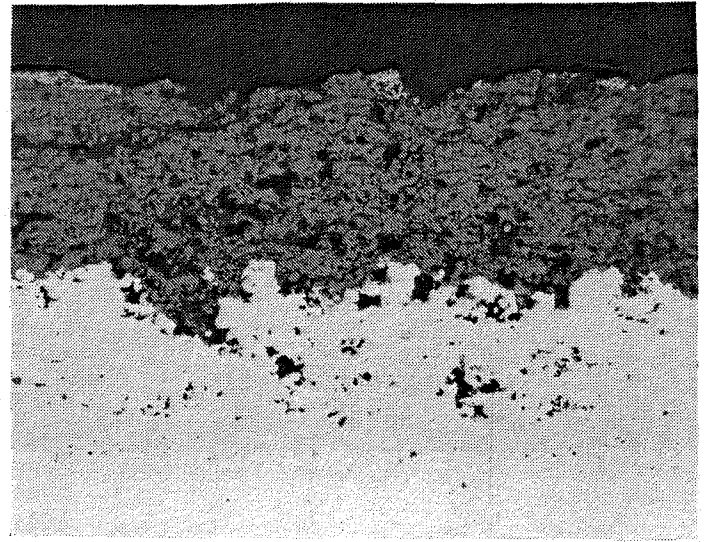
(d) Near Trailing Edge, Pressure Side 100 $\mu$

Thermal-barrier-coated blades which had sustained damage in the cascade rig test were evaluated by metallographic and microprobe examinations. Metallographic examination showed the coating to be intact and adherent to the substrate in areas where the blade metal had not been damaged. Figure 38 shows optical micrographs of several regions of the left-most blade in Figure 36. In the region adjacent to the leading edge where the blade metal had melted, the EA Ni-Cr-Al-Hf coating was found to be missing due to either melting or interdiffusion in the substrate and/or bond coat. Despite the loss of the EA Ni-Cr-Al-Hf coating, the bond coat layer and top coat of the TBC system were still present and adhered together. The thermal barrier coating and EA Ni-Cr-Al-Hf coating on other regions of the blade, such as the suction side, near the trailing edge and platform, appeared intact and in good condition.

Figure 38. Photomicrographs of Thermal-Barrier-Coated, René 150, CF6-50, Stage 1 HPT Blade (No. 0395) After 390 Cycles of Cascade Rig Testing.

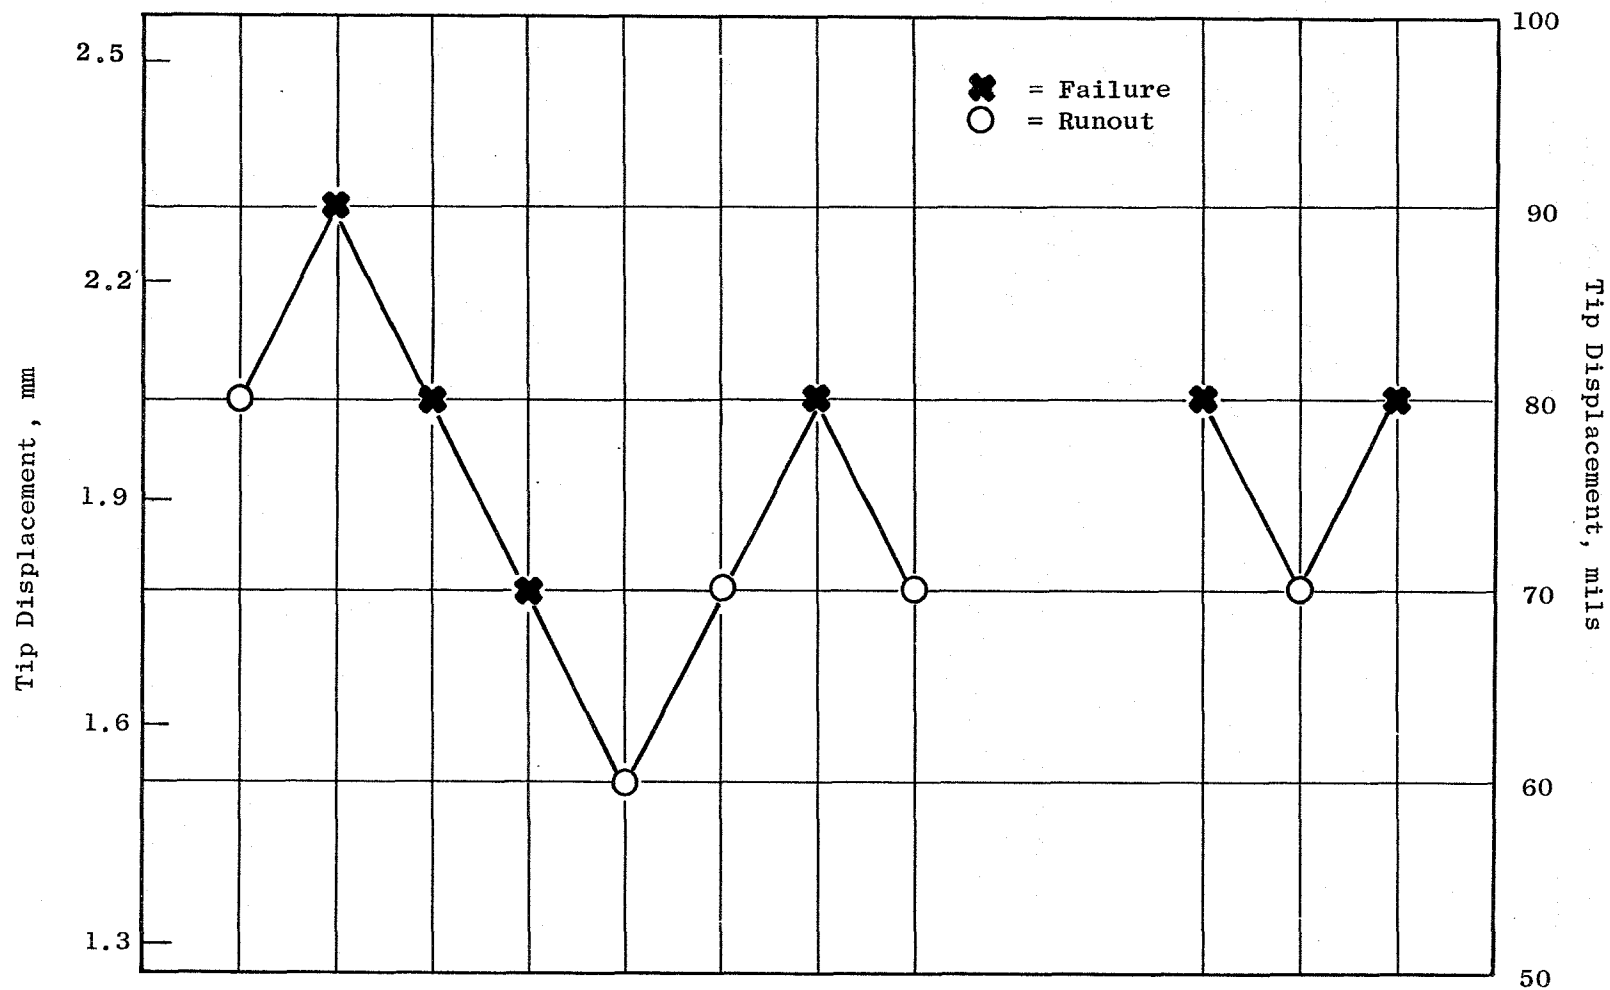
High cycle fatigue testing of the blades (coated under Contract NAS3-21727) was begun with a blade tip deflection of 2 mm (0.080 in.). A stair-case method was used to determine the tip deflection to be used on subsequent blades. If failure occurred at a given tip deflection, the next blade was tested with 0.25 mm (0.010 in.) less deflection; if failure did not occur (runout was  $10^7$  cycles), the next blade was run with 0.25 mm (0.010 in.) greater deflection. The test results are shown along with the results from

the other coated blades in Figure 41. The average HCF strength of the thermal-barrier-coated blades compared favorably to the strength of uncoated blades, and the thermal-barrier-coated blades were qualified to be run in engine evaluation.

Figure 41. Component High Cycle Fatigue Test Results of Thermal-Barrier-Coated Blades at 1200 K (1700° F).

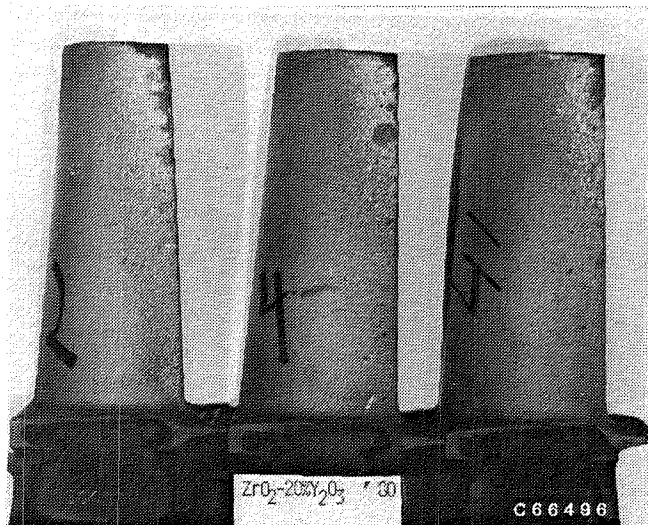
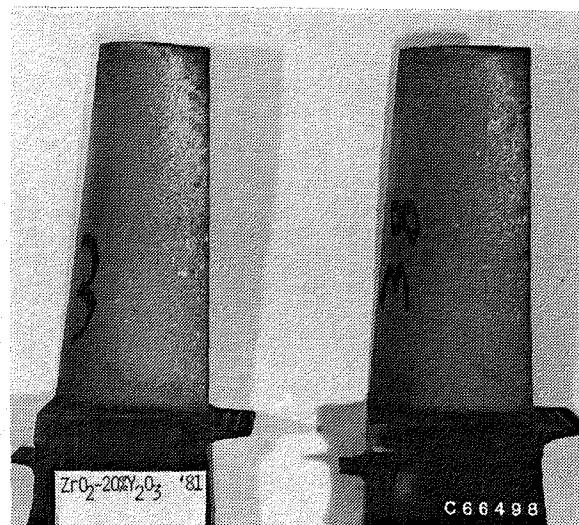
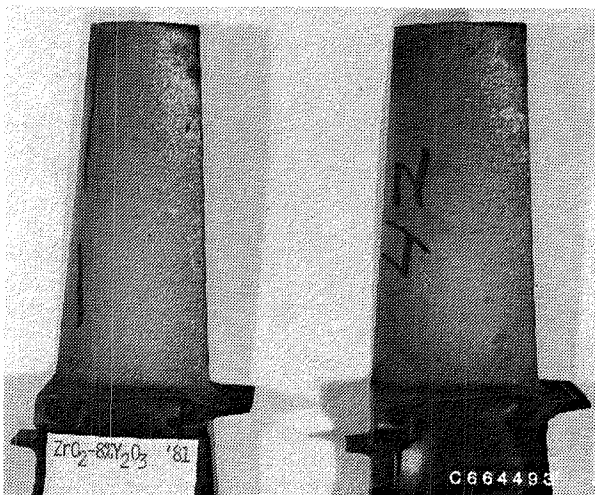
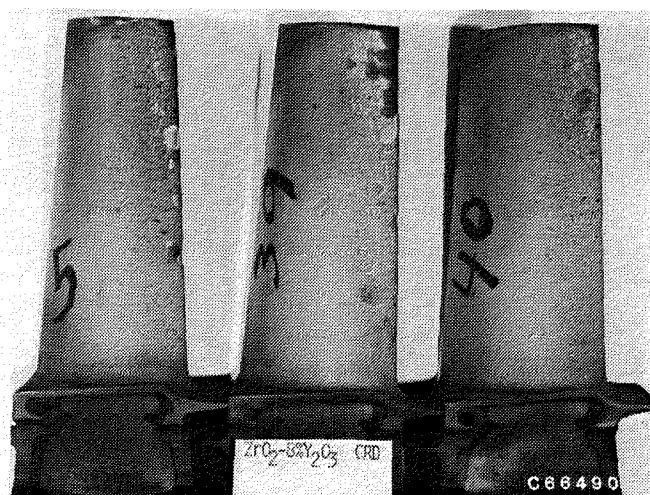
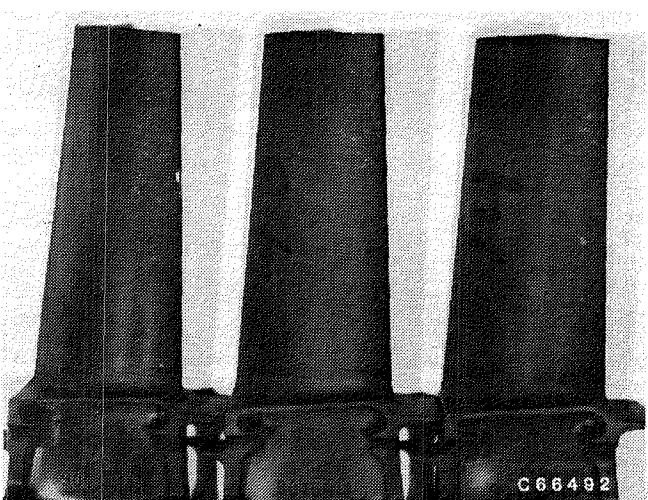
Visual examination of the thermal-barrier-coated blades after removal from the engine showed the TBC to be in excellent condition, except at the leading edge on the suction side, as shown in Figure 47a. Figure 47b shows the pressure side of the engine-tested blades. It was observed that there was no loss of coating on the platforms except for one spalled area (approximately 7.5 by 5 mm) on one blade. The coating on the forward extension of the platform (angel wing) of several of the blades contained deep grooves caused by radial rubs against stationary parts; however, the TBC adjacent to the grooves remained intact. There was no loss of coating from the pressure side of the airfoils or from the greater part of the suction side of the airfoils.

All of the blades had a similar pattern of coating damage confined to the leading edge on the suction side, although the extent of damage varied from blade-to-blade, as can be observed in Figure 47a. In small areas of the leading edge at the blade tip, ranging in size from 20 mm<sup>2</sup> (0.03 in.<sup>2</sup>) to 100 mm<sup>2</sup> (0.16 in.<sup>2</sup>) and averaging 65 mm<sup>2</sup> (0.1 in.<sup>2</sup>), the entire thickness of the ceramic layer was missing. The loss of ceramic layer in these areas may be related to a number of factors, such as development of cracks in the ceramic layer during tip grinding, spallation of the ceramic layer due to thermal cycling and geometry effects, and loss due to erosion and impact damage.

In other areas of the forward part on the suction side, the damage was characterized by a roughened coating surface, the presence of pockmarks and small craters, and isolated loss of ceramic coating. In these areas, a thin layer of the ceramic coating was still present. This damage appeared to be impact and erosion damage caused by particulate impingement. A tabulation listing the areas of the two extents of damage for each blade is given in Table XV. As noted in the table, the average size of the damaged area was 112 mm<sup>2</sup> (0.174 in.<sup>2</sup>) which is only 1.2% coated area. The average size area where all of the ceramic layer was missing was only 0.6% of the coated area. Blades without a thermal barrier coating (Codep only) also showed signs of particulate impingement at the leading edge on the suction side, as shown in Figure 47a. This area appeared rougher than the rest of the airfoil and had a greenish foreign material adhering to the surface at the leading edge. An attempt was made to identify the source of this material by chemical analysis.

Figure 47a. Photos of Engine-Tested (1000 "C" Cycles) CF6-50 Stage 2 Blades (René 80) With and Without TBC, Suction Side.

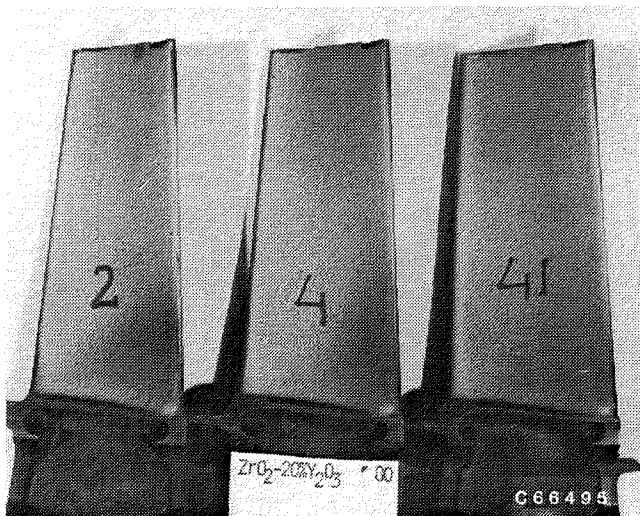
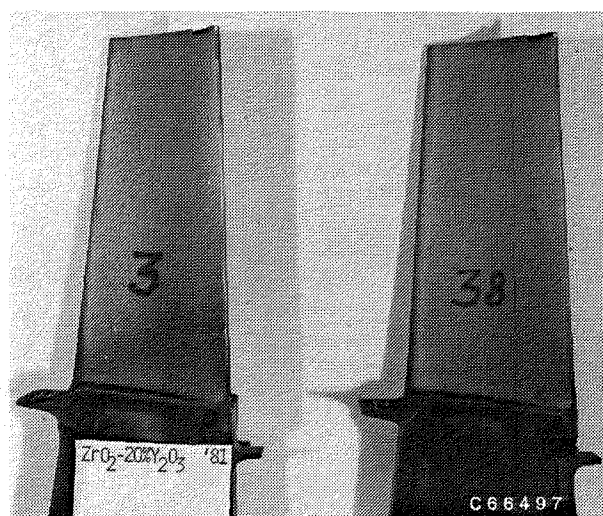
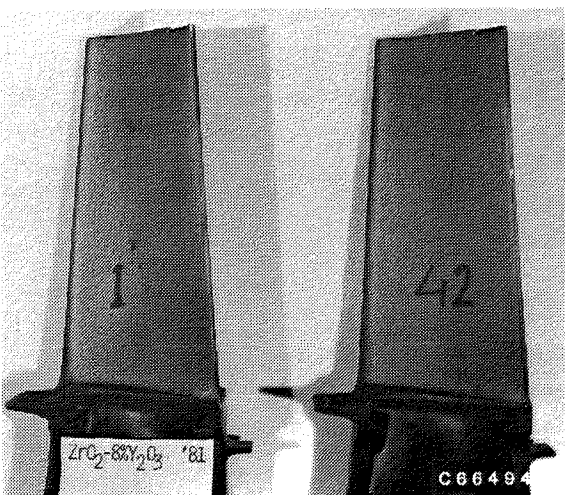
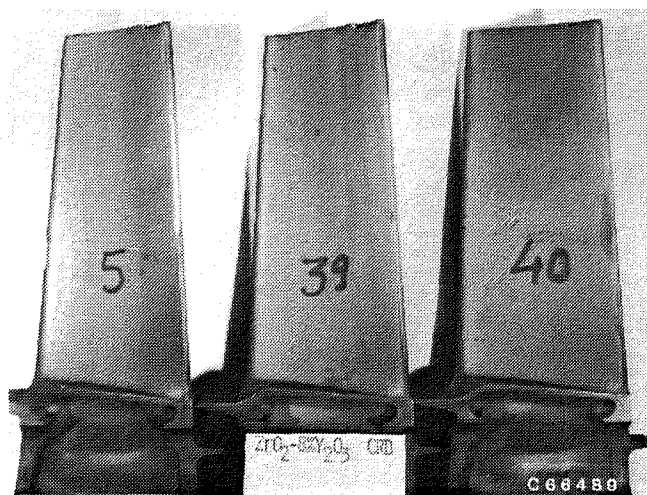
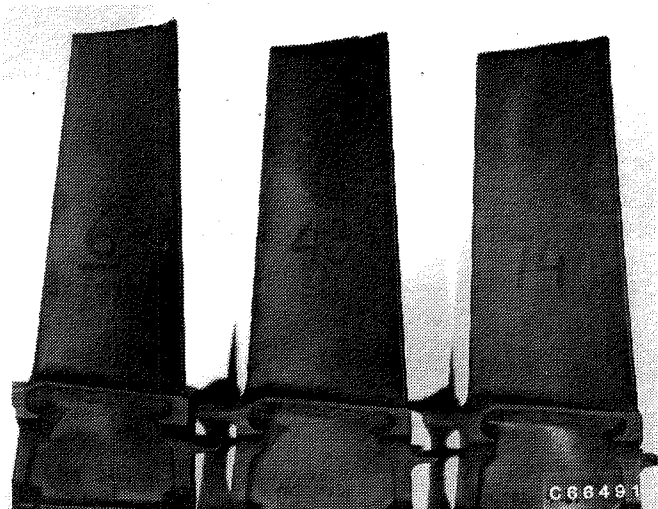
Figure 47b. Photos of Engine-Tested (1000 "C" Cycles) CF6-50 Stage 2 Blades (René 80) With and Without TBC, Pressure Side.

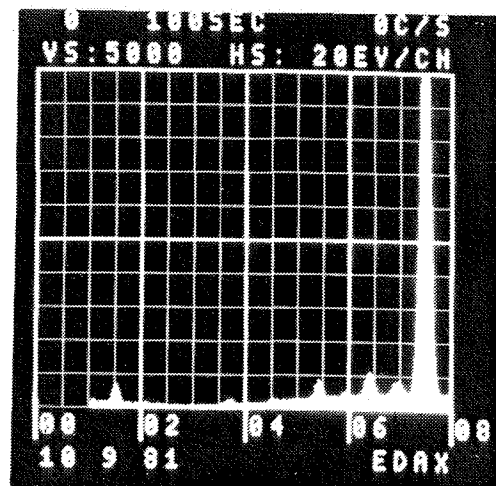
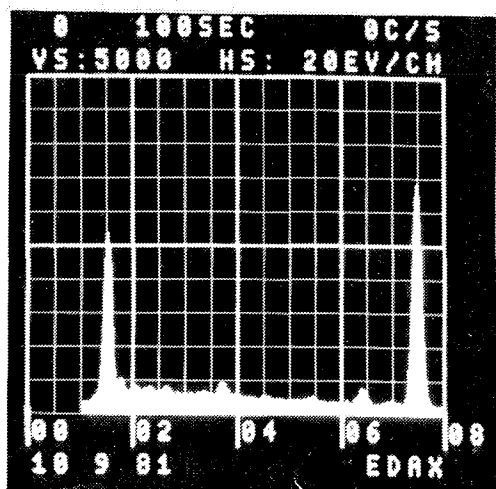
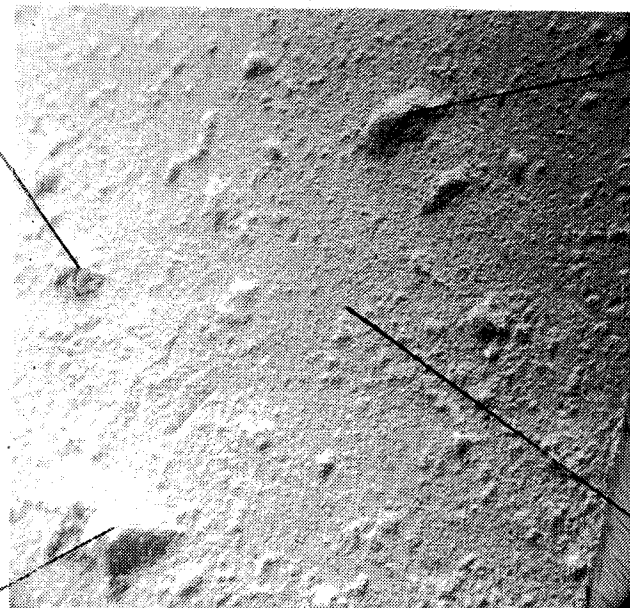
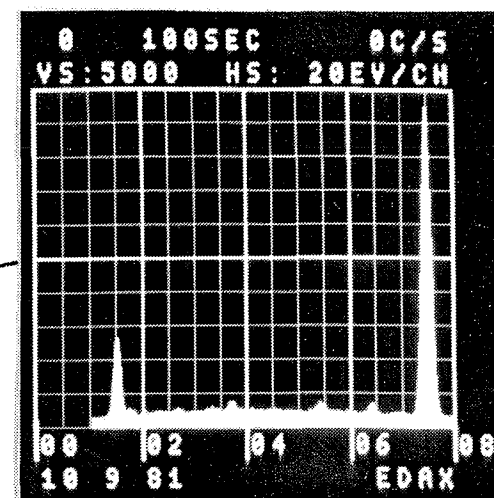
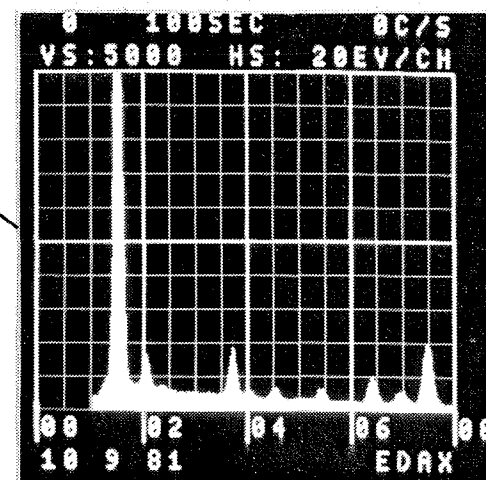
EDAX results, Figure 48, showed the deposits to be mostly Ni-Al with the amount of aluminum varying from 5% to 40%. Other minor elements detected were Co, Fe, Cr, and Ca. Although the exact source of the material in the observed deposits is not known because of the many possible sources of Ni and Al in the engine, it is known that some nickel-aluminum material was lost from the Stage 1 shrouds during the engine test and possibly was the particulate matter that damaged the TBC. The presence of particulate matter in the gas stream is not uncommon and should be taken into consideration in the design and application of thermal-barrier-coatings on HPT components.

Figure 48. Chemical Analysis by EDAX of the Greenish Deposits on the Leading Edge, Suction Side of an Engine-Tested, Stage 2 Blade.

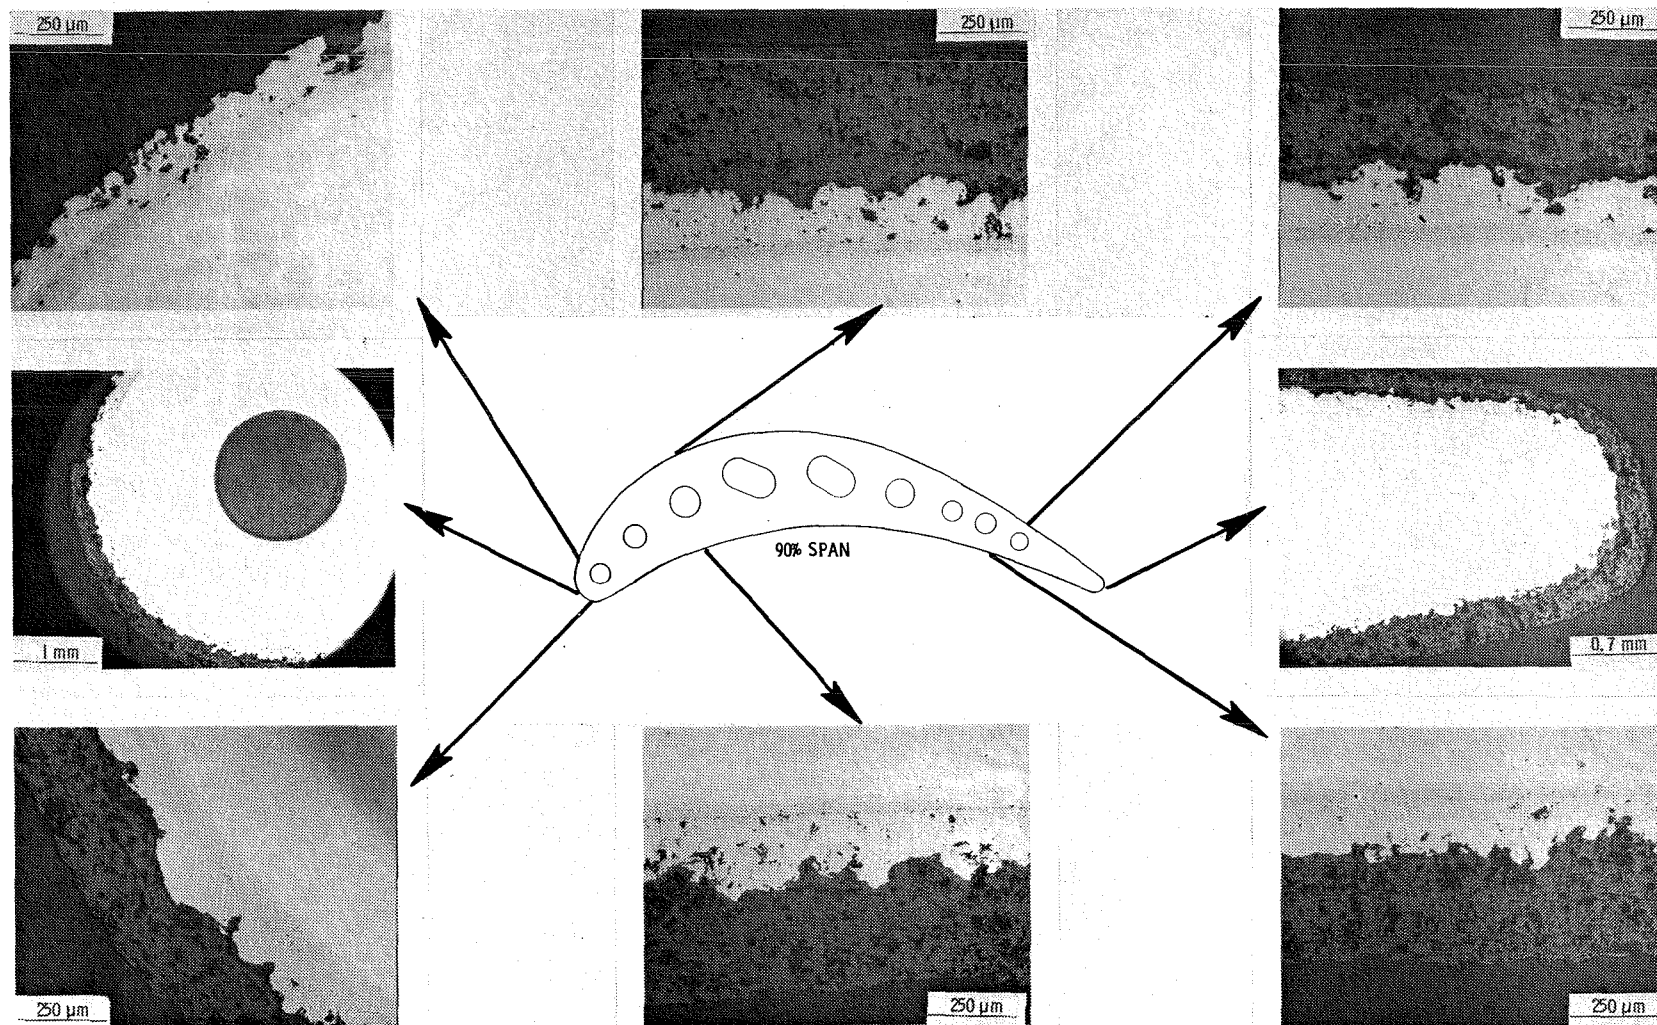
Three of the engine-tested thermal-barrier-coated blades, one with each type of ceramic layer and one blade without TBC (Codep only), were sectioned at 40%, 70%, and 90% span and in the platform region and prepared for metallographic examination. Microstructural examination showed the thermal barrier coatings on all three blades to be in excellent condition in all areas except at the leading edge of the suction side where the ceramic layer had been damaged. The blade with Codep coating only showed normal microstructure without any damage.

Figure 49a. Photomicrographs of Engine-Tested (1000 "C" Cycles) CF6-50 Stage 2 Blade With TBC (Ni-22Cr-10Al-1Y/ZrO<sub>2</sub>-20%Y<sub>2</sub>O<sub>3</sub> Duplex), 90% Span (Blade No. 41, Table XV).

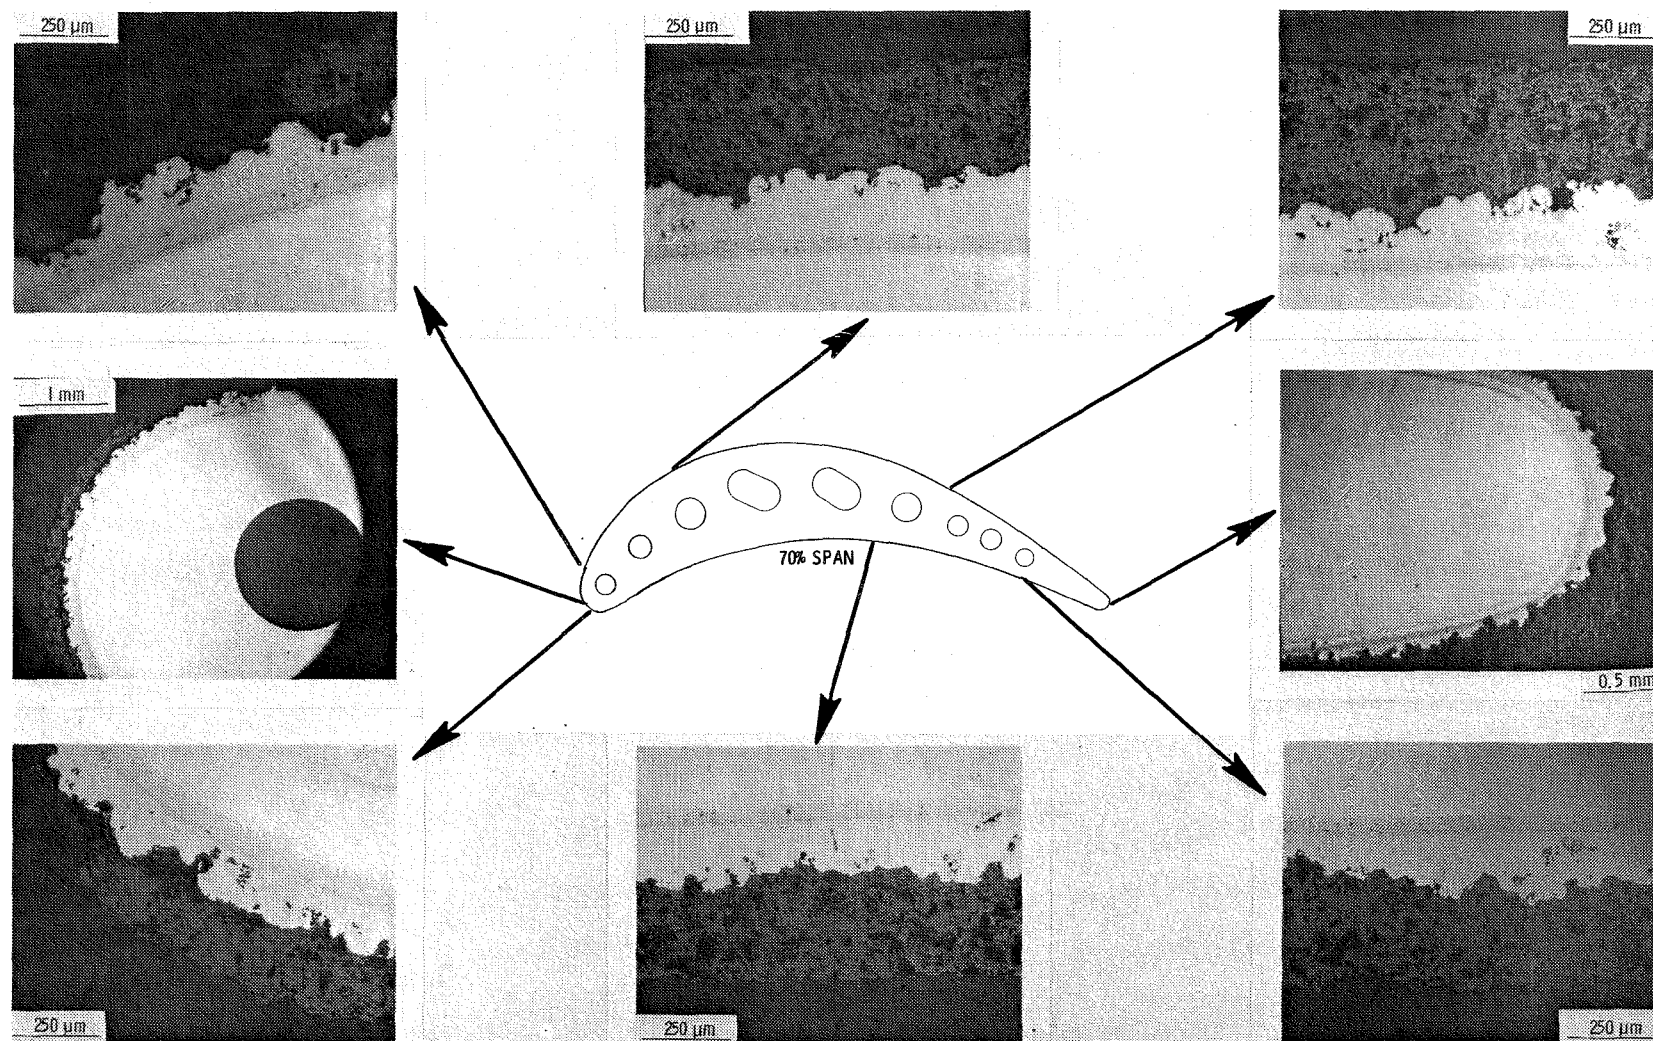
Figure 49b. Photomicrographs of Engine-Tested (1000 "C" Cycles) CF6-50 Stage 2 Blade With TBC (Ni-22Cr-10Al-1Y/ZrO<sub>2</sub>-20%Y<sub>2</sub>O<sub>3</sub> Duplex), 70% Span (Blade No. 41, Table XV).

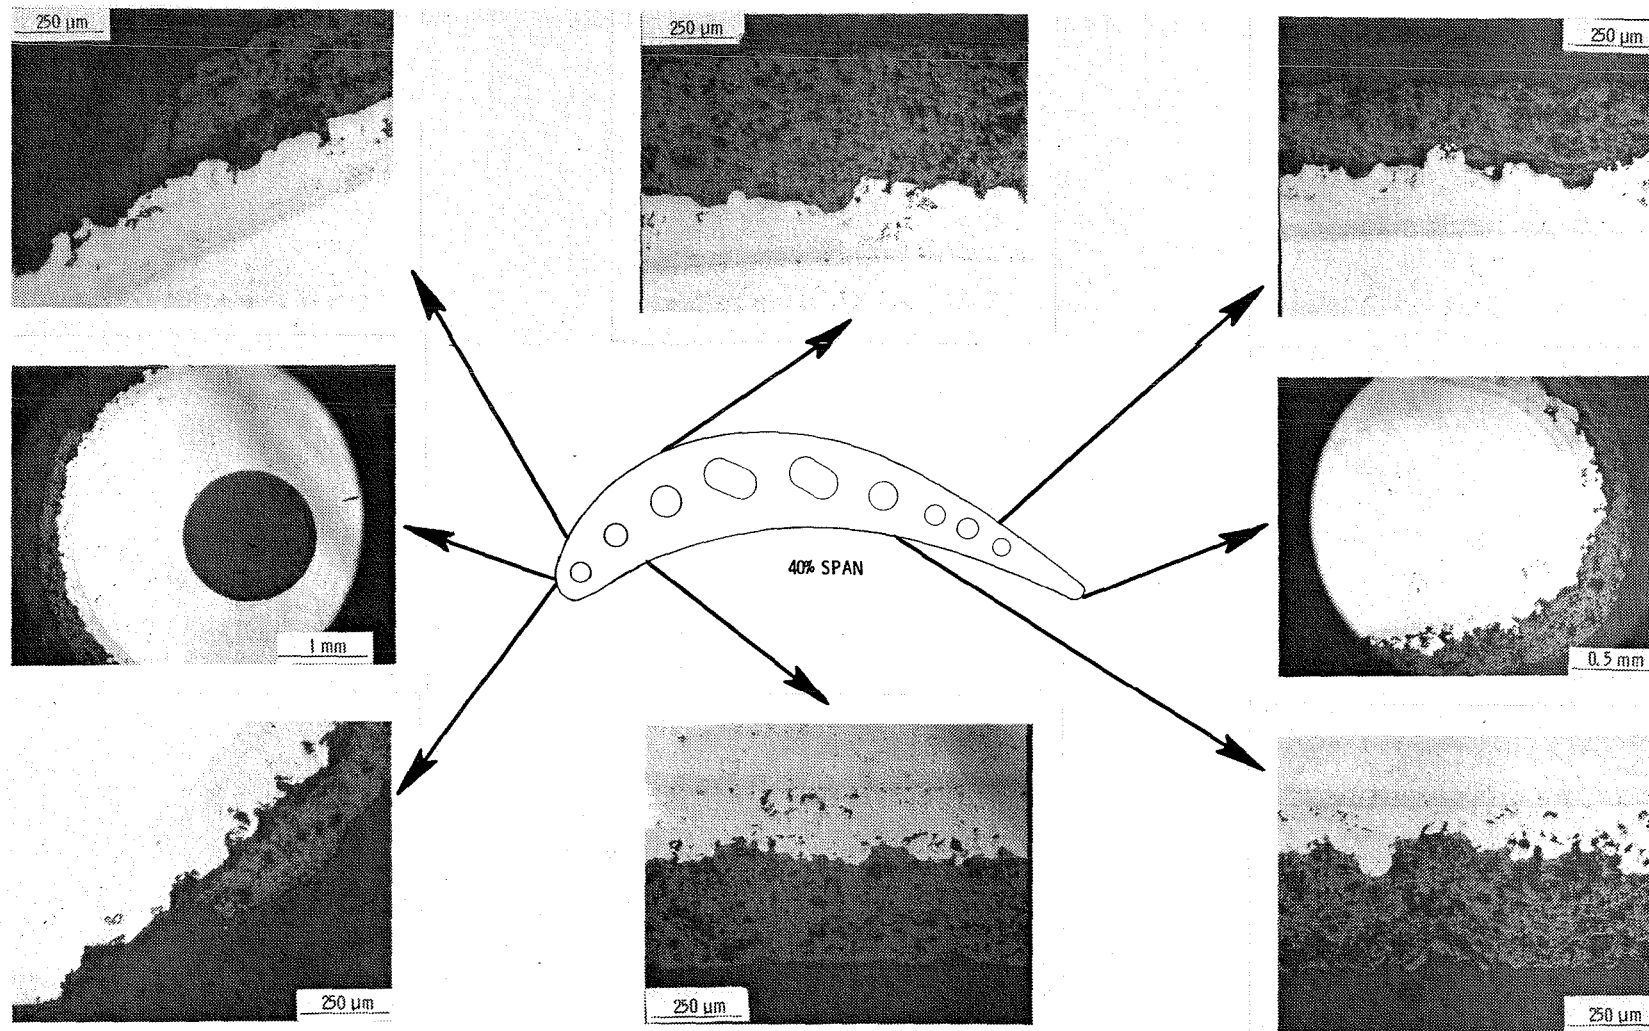
Figure 49c. Photomicrographs of Engine-Tested (1000 "C" Cycles) CF6-50 Stage 2 Blade With TBC (Ni-22Cr-10Al-1Y/ZrO<sub>2</sub>-20%Y<sub>2</sub>O<sub>3</sub> Duplex), 40% Span (Blade No. 41, Table XV).

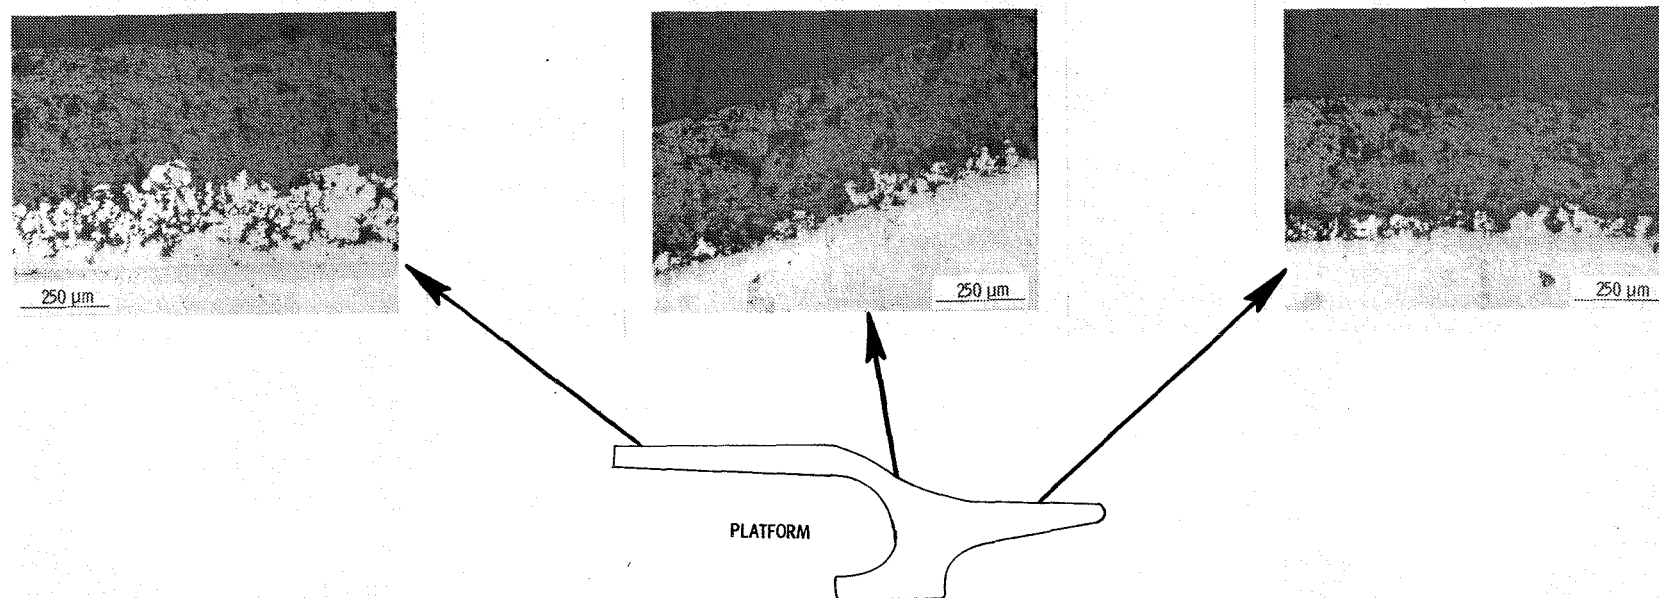
Figure 49d. Photomicrographs of Engine-Tested (1000 "C" Cycles) CF6-50 Stage 2 Blade With TBC (Ni-22Cr-10Al-1Y/ZrO<sub>2</sub>-20%Y<sub>2</sub>O<sub>3</sub> Duplex), Platform (Blade No. 41, Table XV).

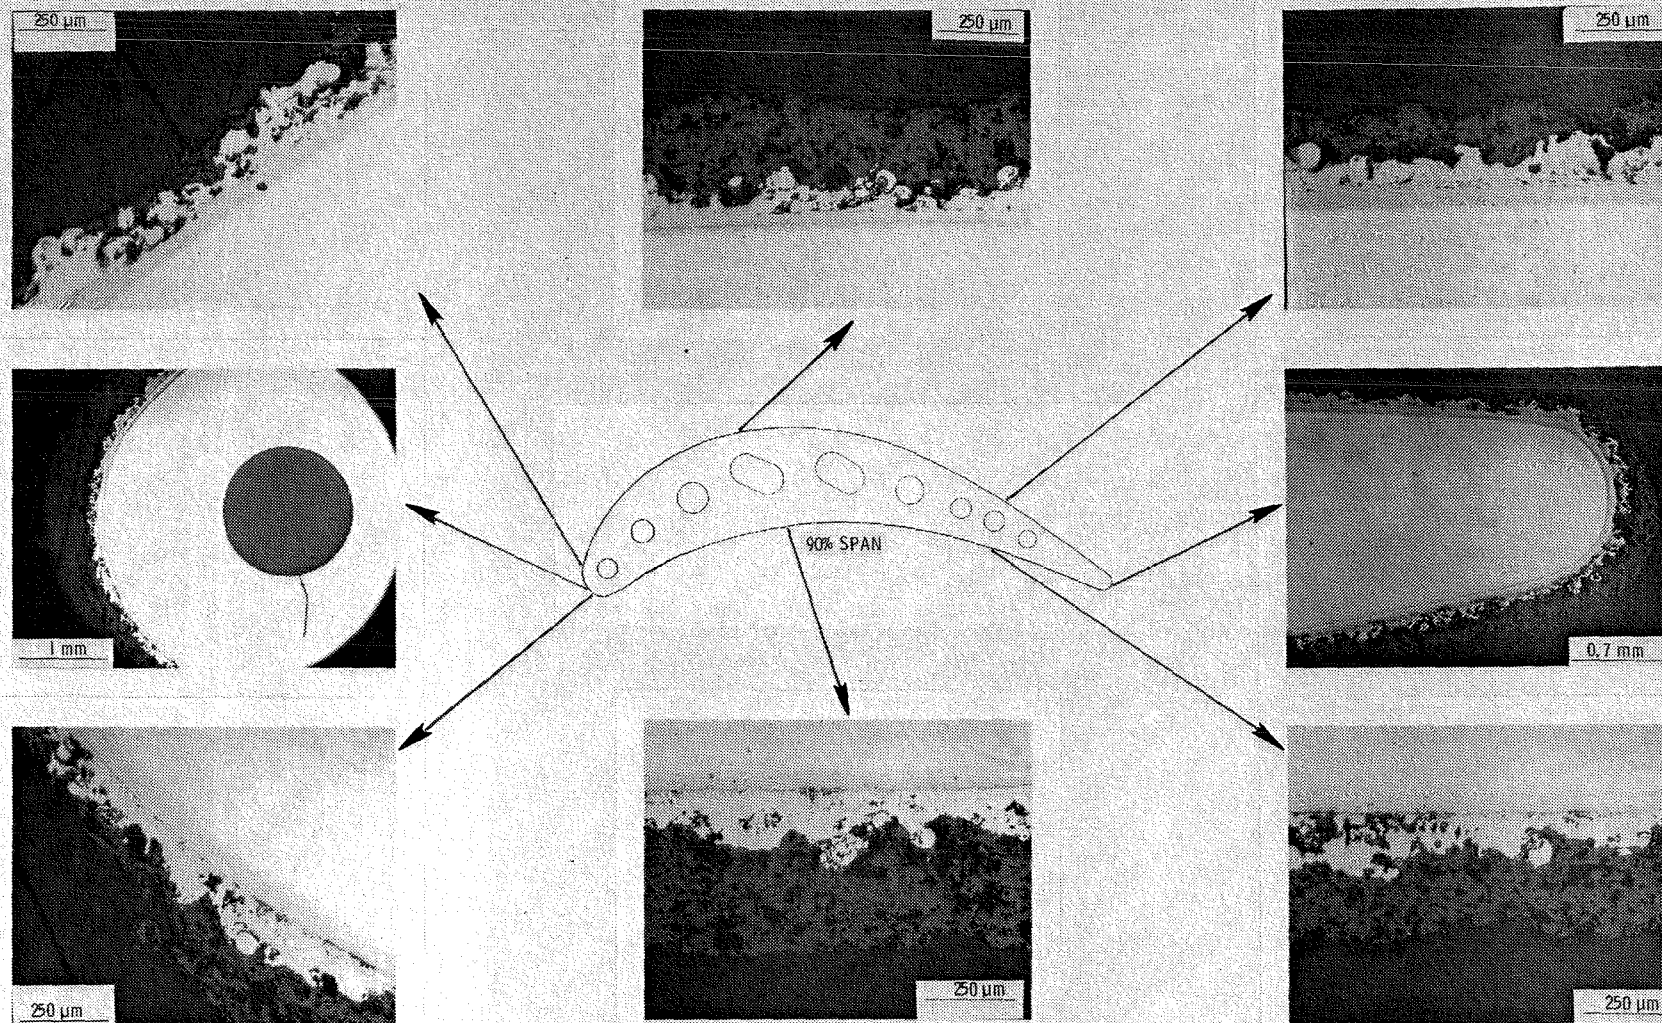
Figure 50a. Photomicrographs of Engine-Tested (1000 "C" Cycles) CF6-50 Stage 2 Blade With TBC (Ni-22Cr-10Al-1Y/ZrO<sub>2</sub>-8%Y<sub>2</sub>O<sub>3</sub> Duplex), 90% Span (Blade No. 42, Table XV).

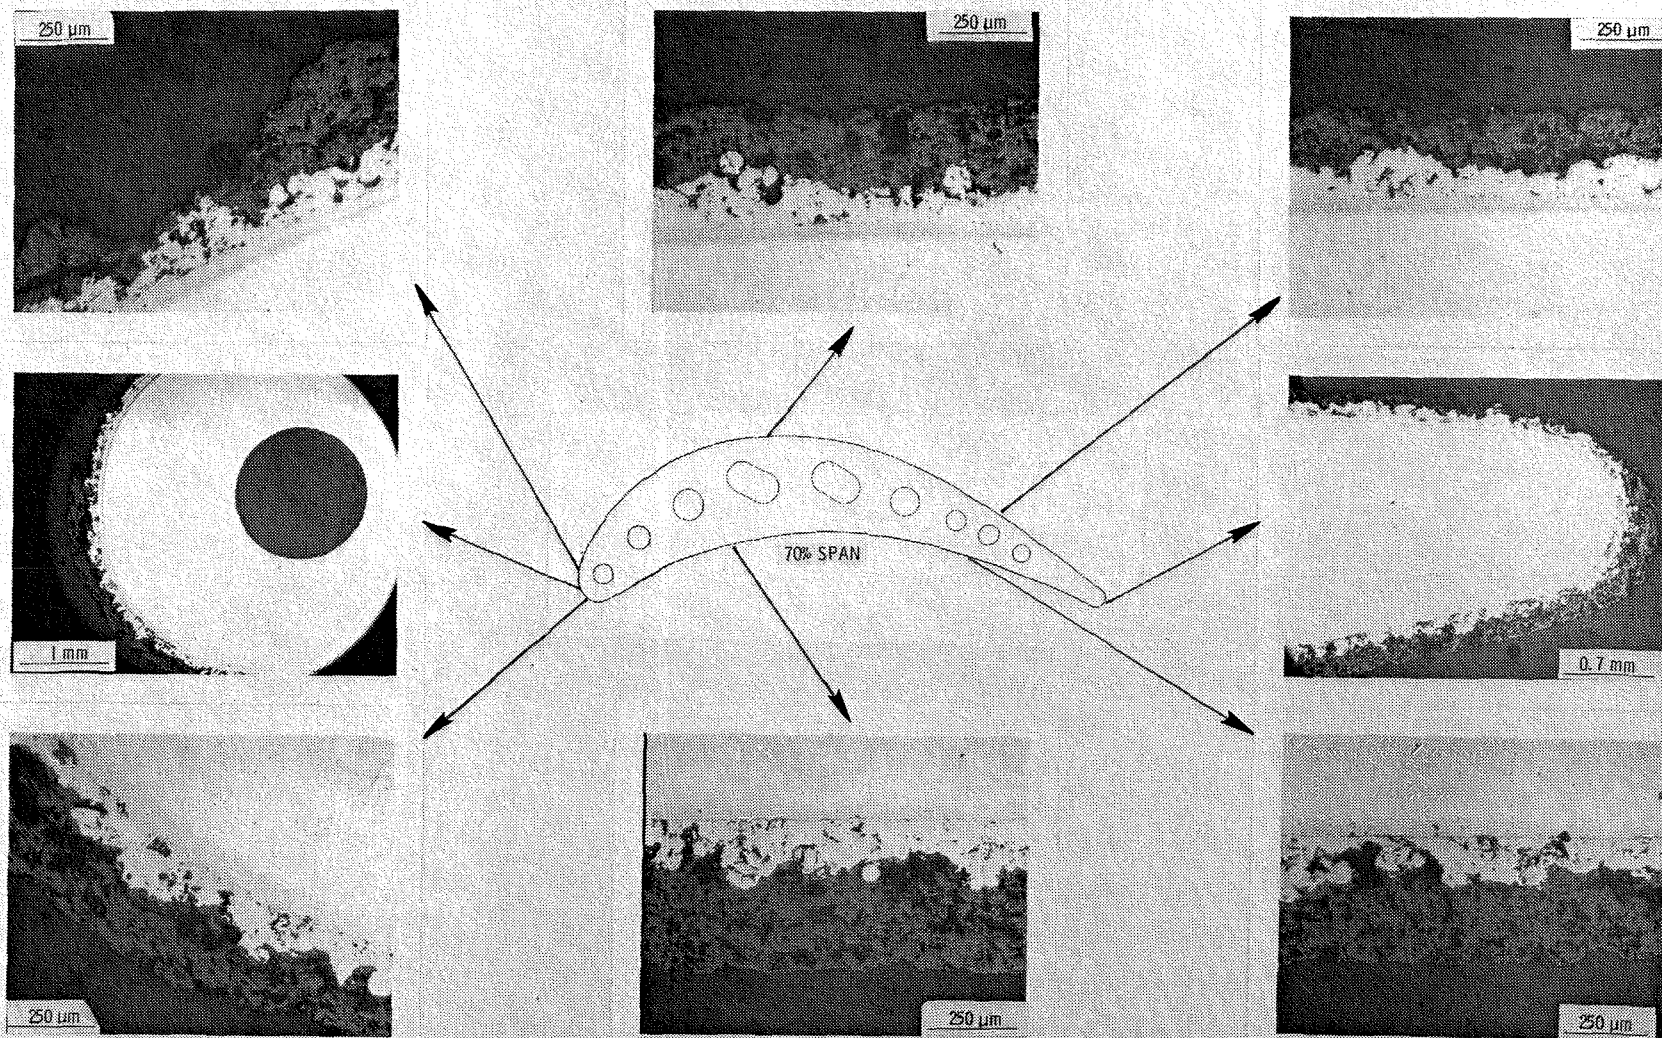
Figure 50b. Photomicrographs of Engine-Tested (1000 "C" Cycles) CF6-50 Stage 2 Blade With TBC (Ni-22Cr-10Al-1Y/ZrO<sub>2</sub>-8%Y<sub>2</sub>O<sub>3</sub> Duplex), 70% Span (Blade No. 42, Table XV).

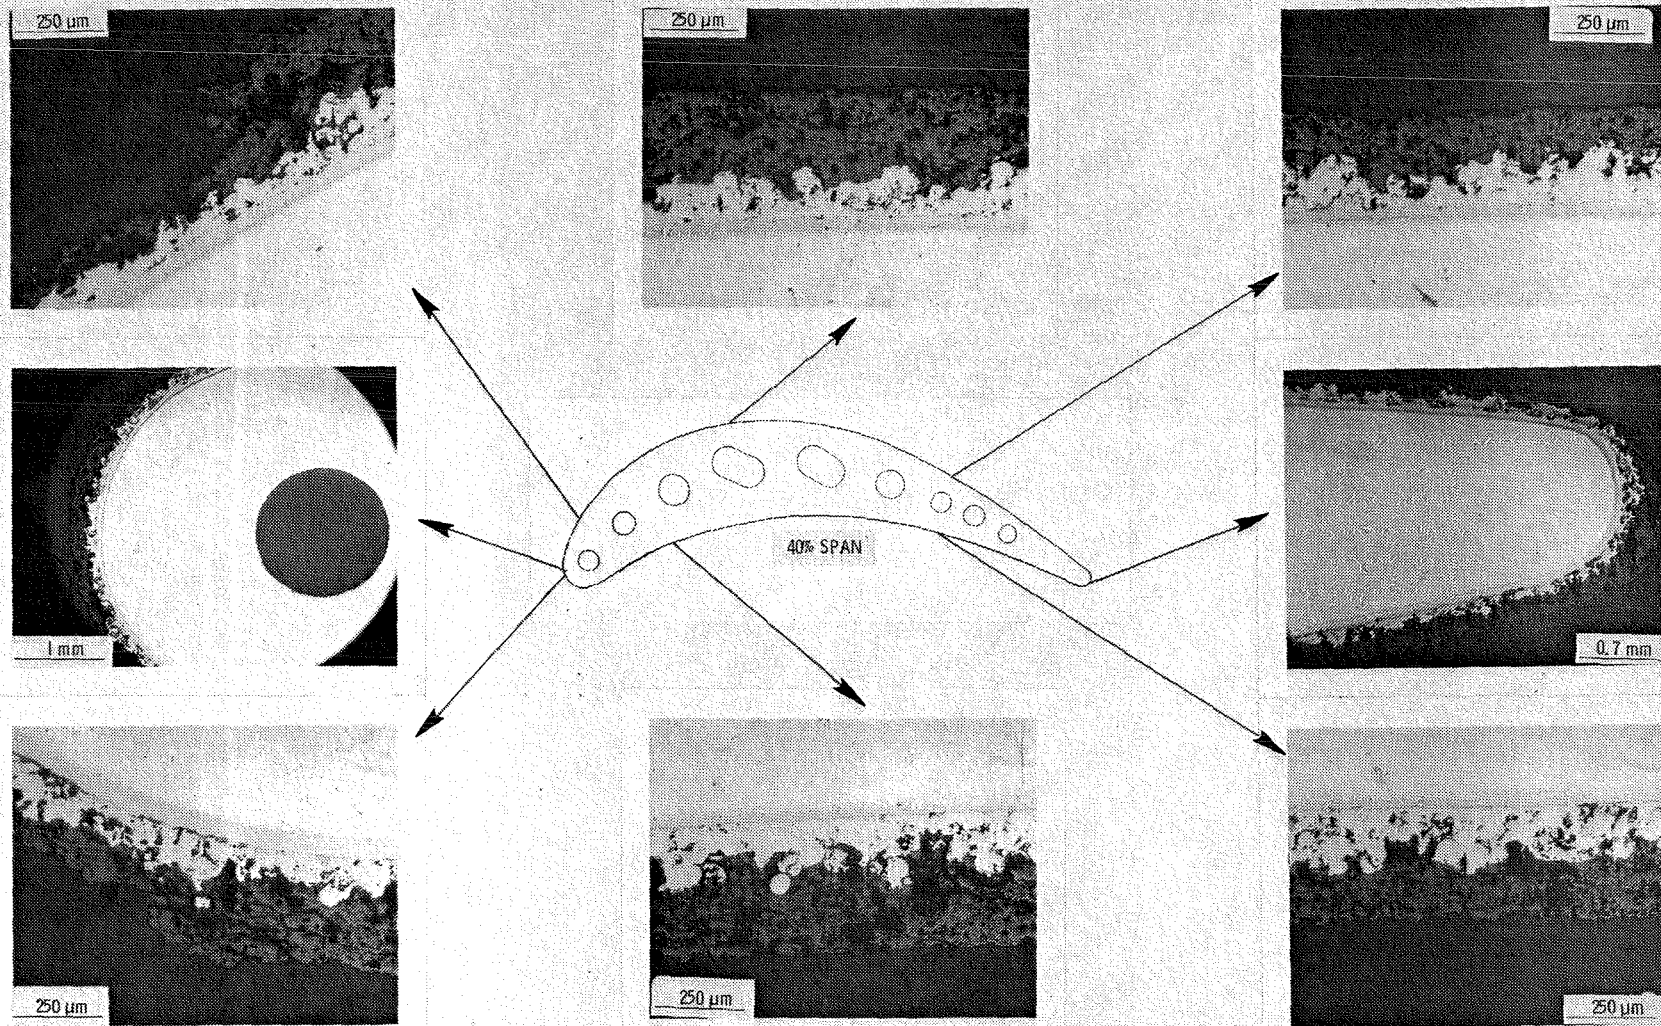
Figure 50c. Photomicrographs of Engine-Tested (1000 "C" Cycles) CF6-50 Stage 2 Blade With TBC (Ni-22Cr-10Al-1Y/ZrO<sub>2</sub>-8%Y<sub>2</sub>O<sub>3</sub> Duplex), 40% Span (Blade No. 42, Table XV).

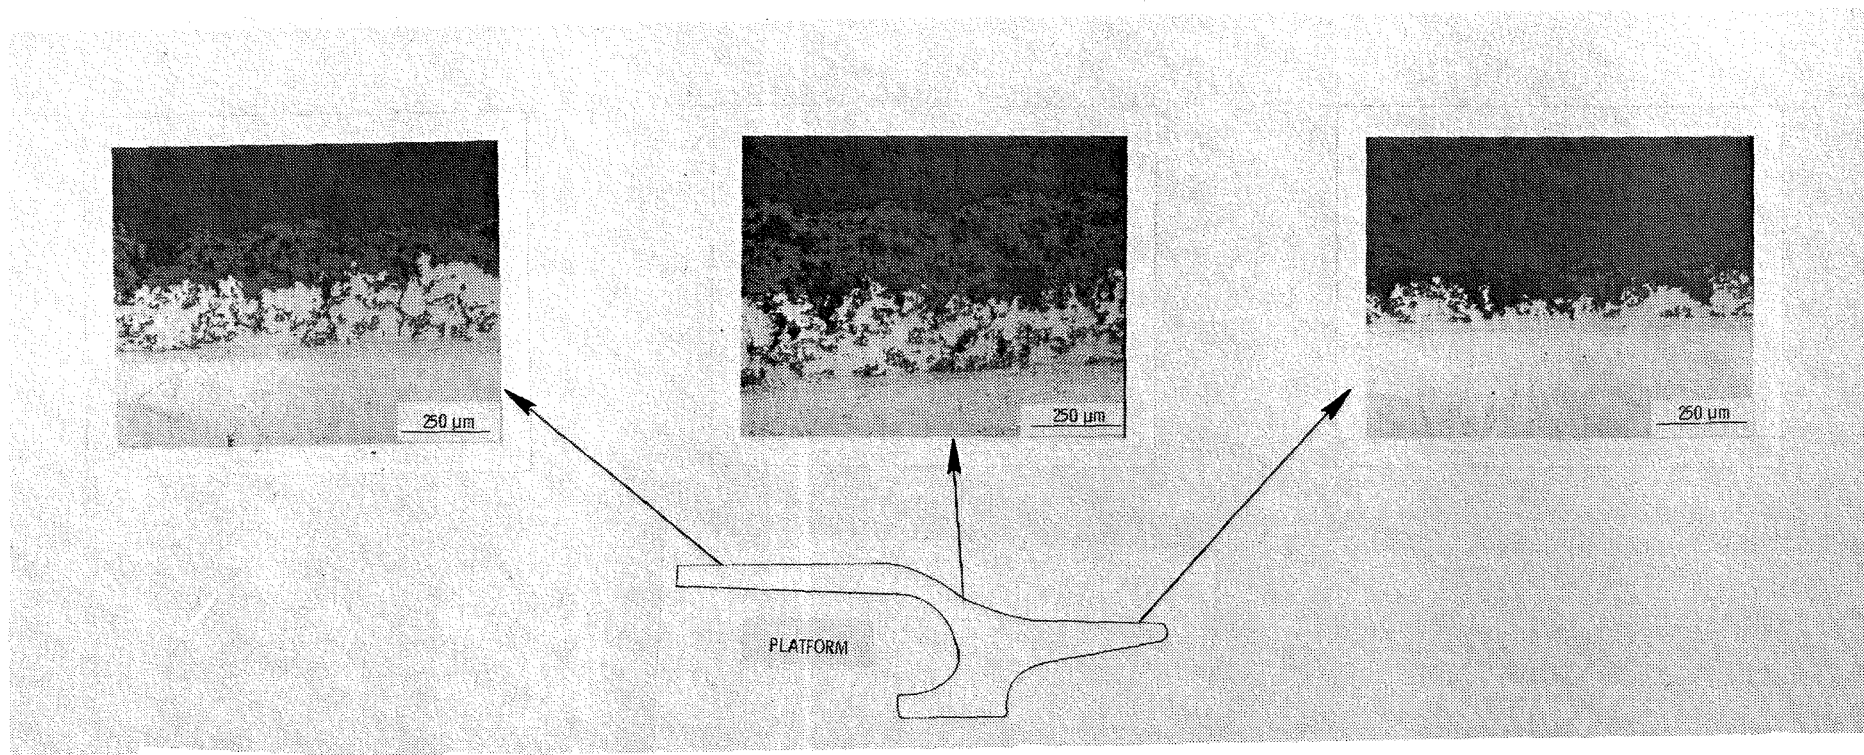
Figure 50d. Photomicrographs of Engine-Tested (1000 "C" Cycles) CF6-50 Stage 2 Blade With TBC (Ni-22Cr-10Al-1Y/ZrO<sub>2</sub>-8%Y<sub>2</sub>O<sub>3</sub> Duplex), Platform (Blade No. 42, Table XV).
